THE SAN FRANCISCO-OAKLAND BAY BRIDGE EAST SPAN SEISMIC SAFETY PROJECT

SFOBB Dismantling Project Update

Summary of 2017 Pier Demolition Results

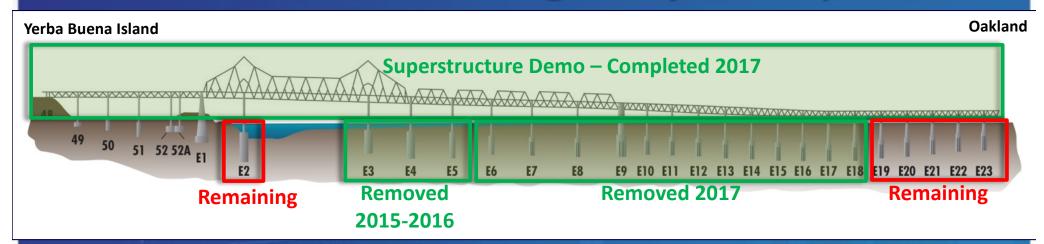
LOCATION

Superstructure

• Piers E3 - E5

• Piers E6 - E18

Piers E2, E19-E23

WORK SUMMARY

Removal Completed 2017

Removed in 2015 and 2016

Removed in 2017

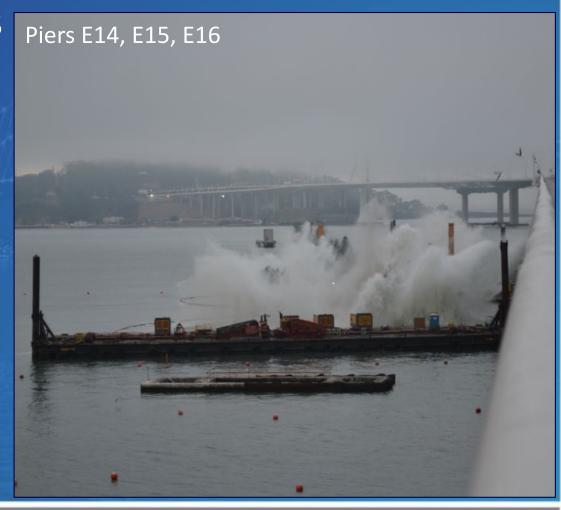
- Above water portions mechanically removed
 - Wire-saw cutting,hoe-ram
- Drilling and loading of charges
- Implosion of underwater portions

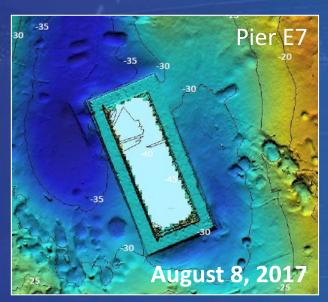
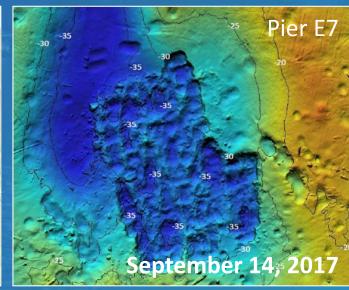
- Rubble removed to debris removal limit.
- Clean-up verified with bathymetry surveys
- Completed by November 30, 2017
- ~28,210 cubic yards authorized for in-situ (E4 to E18)
- ~24,180 cubic yards placed in-situ (E4 to E18)

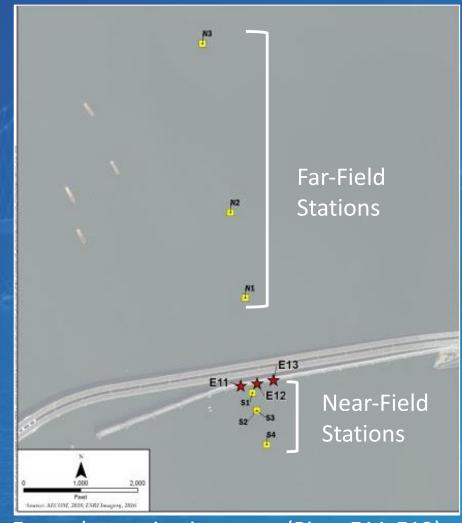
Example monitoring array (Piers E11-E13)

- Near-field
 monitoring all 6
 controlled blast
 events within 1,100
 feet
- Far-field monitoring on 4 of 6 controlled blast events from 1,500 to 6,000 feet

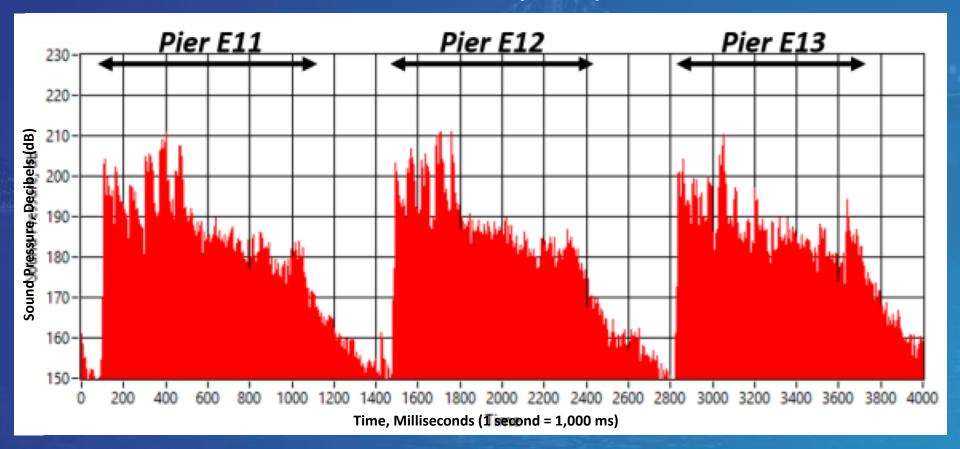
Example Sound Pressure Signatures at 500 feet (Piers E11-E13)
Half second between pier implosions

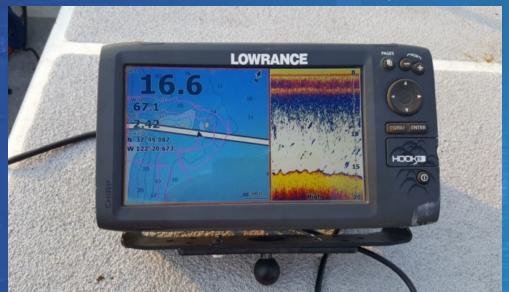
- Pre-Blast Sonar
 - Two sonar passes were made at approx. 500 and 750 feet around each pier approximately 4 hours prior to each event.
 - Very few areas of fish assemblages were noted in survey areas
 - Correlation difficult to see when compared to post-blast salvage

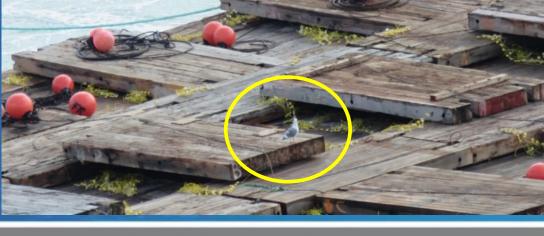
Avian Monitoring

- Monitored 30 min prior to blasts; bird strike counts were performed post-blast
- Sound cannons flushed birds prior to blasts. Drone used when cannons were ineffective
- No take of avian species occurred

Bird predation (bird strikes) was considered low for all

implosions

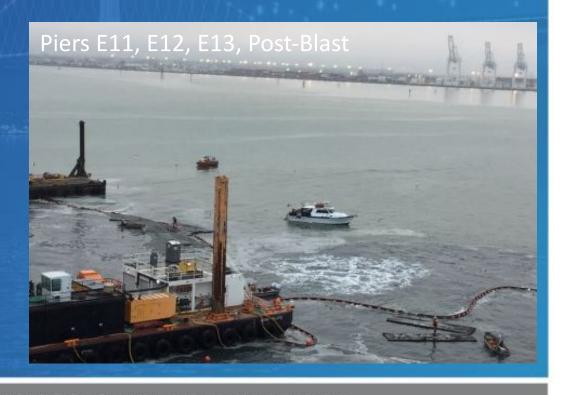
- 2017 Monitoring Methods:
 - Fixed buoy monitoring
 - Barge mounted sondes
 - Dynamic plume mapping
 - Static plume tracking
 - Eelgrass ESA monitoring
 - Sediment Assessment

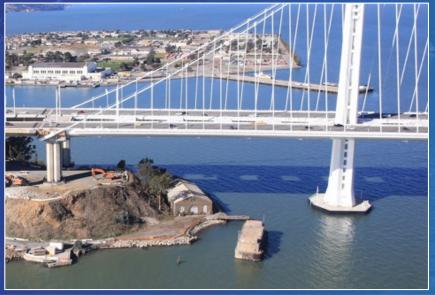
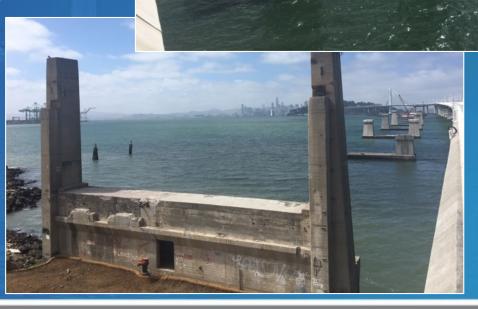
Oakland Touchdown (New Structure on Piers E21-E23)

Demolition (Piers E19-E20)

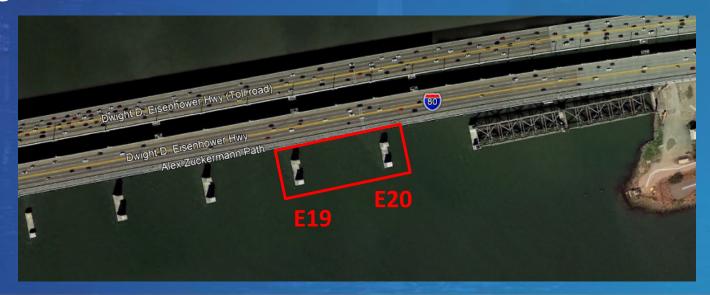
- Demolition using controlled implosions
 - Above water mechanical demolition
 - Below water implosion/ rubble removal
 - Monitoring resources following protocol implemented during 2017 blast events
